Geotechnical Investigation on part of stand 3360, Nelspruit

Report no: K7597-01
Project no: 7597-GB

June 2011

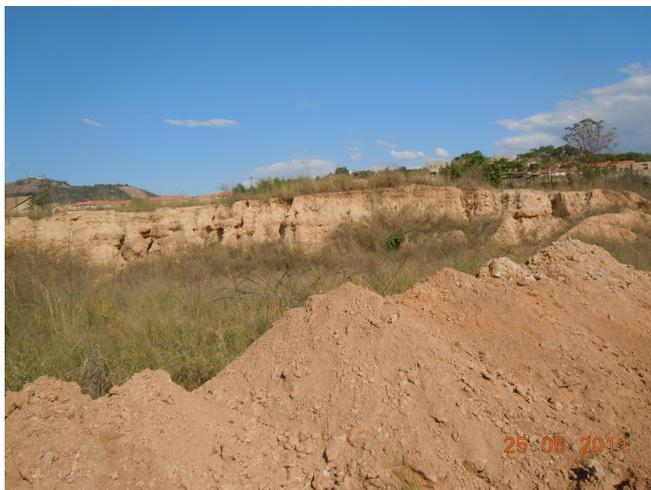
The site is approximately 1,4 hectares. At present the site is undeveloped, but is fairly disturbed with some ground terraces present.
